USAAMRDL TECHNICAL REPORT 72-31

AIRCRAFT CLUTCH ASSEMBLIES, RAMP ROLLER

Jules G. Kish

July 1972

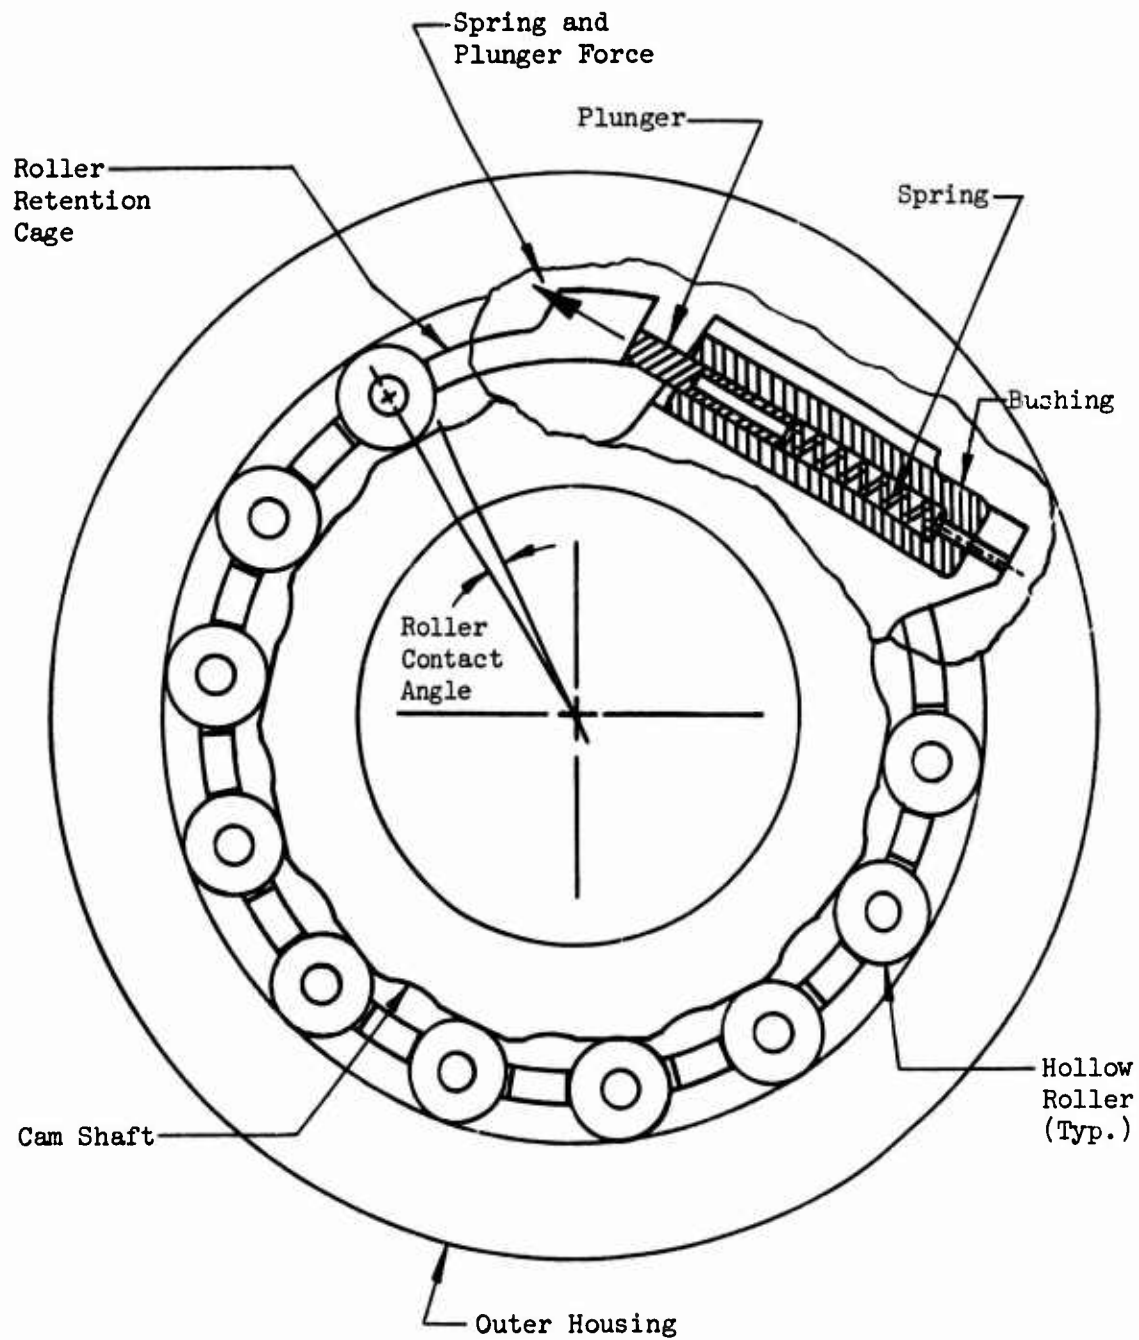
Figure 1. Principal Components of a Ramp-Roller Clutch.

The driving member may be either the cam or the housing. Each arrangement has its own advantages and disadvantages. The advantage of designing the outer housing as the driving member and the cam as the overrunning member is that lubricant can be fed from the center of the rotating cam and out to rollers, cage, and housing by centrifugal force. The disadvantage of cam overrunning is that the rollers are subjected to centrifugal load, which increases wear of rollers and housing. In the design with the cam driving, centrifugal roller loads during full-speed overrunning are eliminated, but the lubrication system must be pressurized to assure lubrication when the cam is stationary. In the high-speed ramp roller clutch design of this program, the configuration with the cam as driving member has been chosen since roller wear at the high speeds encountered is an overriding factor.

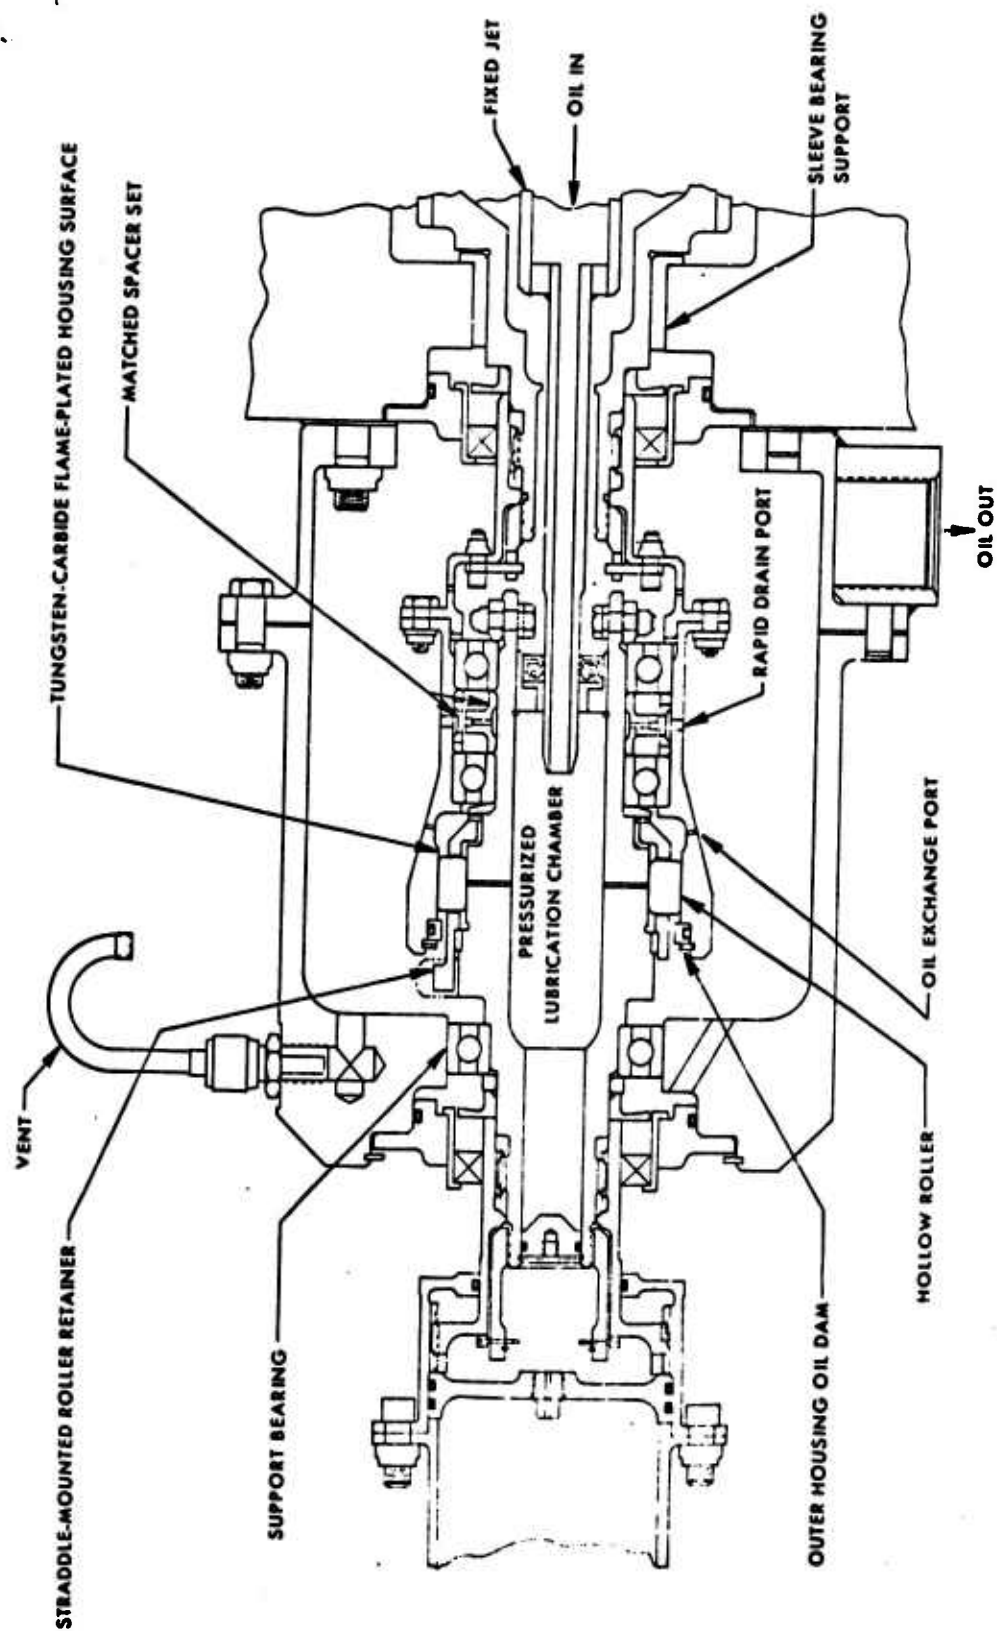
Figure 2. Section View, Ramp Roller Clutch in Test Facility.

As shown in Figure 2, the basic design has a low length-to-diameter ratio, resulting in the benefit of high natural frequency of lateral vibration for the system. This was verified during the design phase of the program using a computer program which determines natural frequency of rotating shaft systems. The first bending natural frequency was found analytically to be 35,060 cpm, which is well above the 26,500 cpm operating frequency. Concentricity tolerances on the outer housing were closely controlled during manufacture since this component creates the highest unbalance forces because it has the largest mass and polar moment of inertia.

A lubrication feature used for the first time on the clutch of this program is the oil-exchange port concept. Two 0.040-inch-diameter holes drain oil from the clutch roller area at approximately 0.6 gpm at 26,500 rpm and under the influence of pressure created by centrifugal force in the area of the oil dam (see Figure 2). This is less than the flow being fed to the roller area, spilling part of the oil over the oil dam and part of the oil through the oil-exchange ports. A constant turnover of new, cool oil is presented to the roller contact area; stagnant, trapped oil is prevented. Field experience has shown that frequently this area of the ramp-roller clutch outer

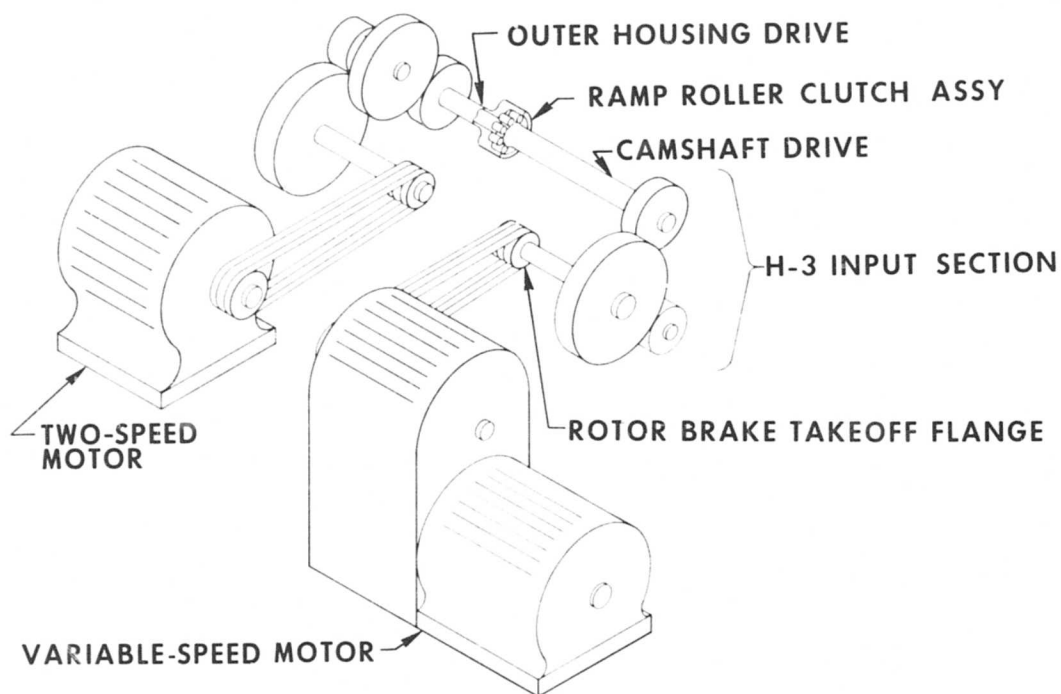
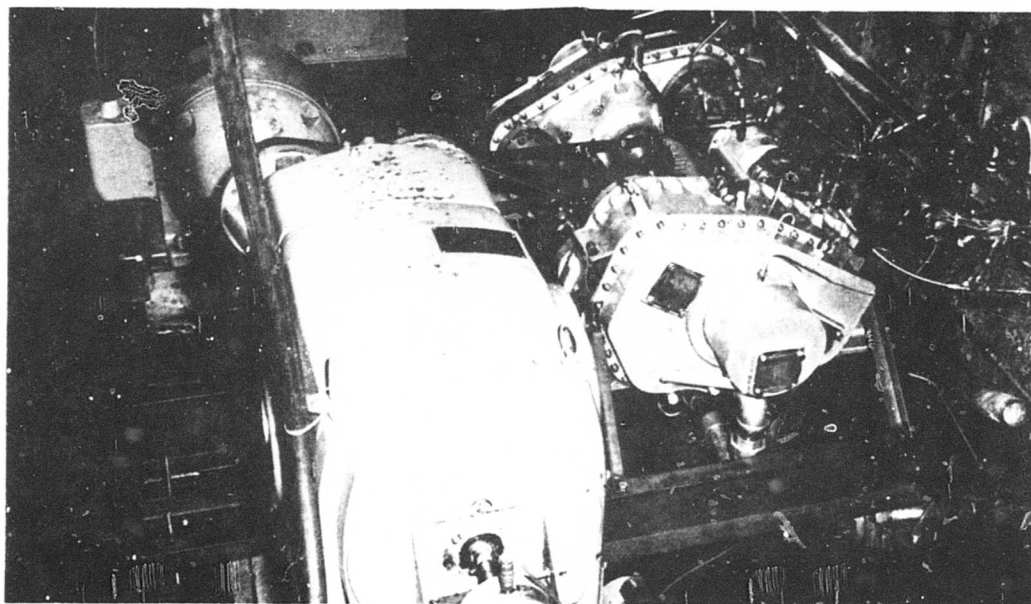
Figure 3. Schematic Arrangement, Dynamic Test Facility.

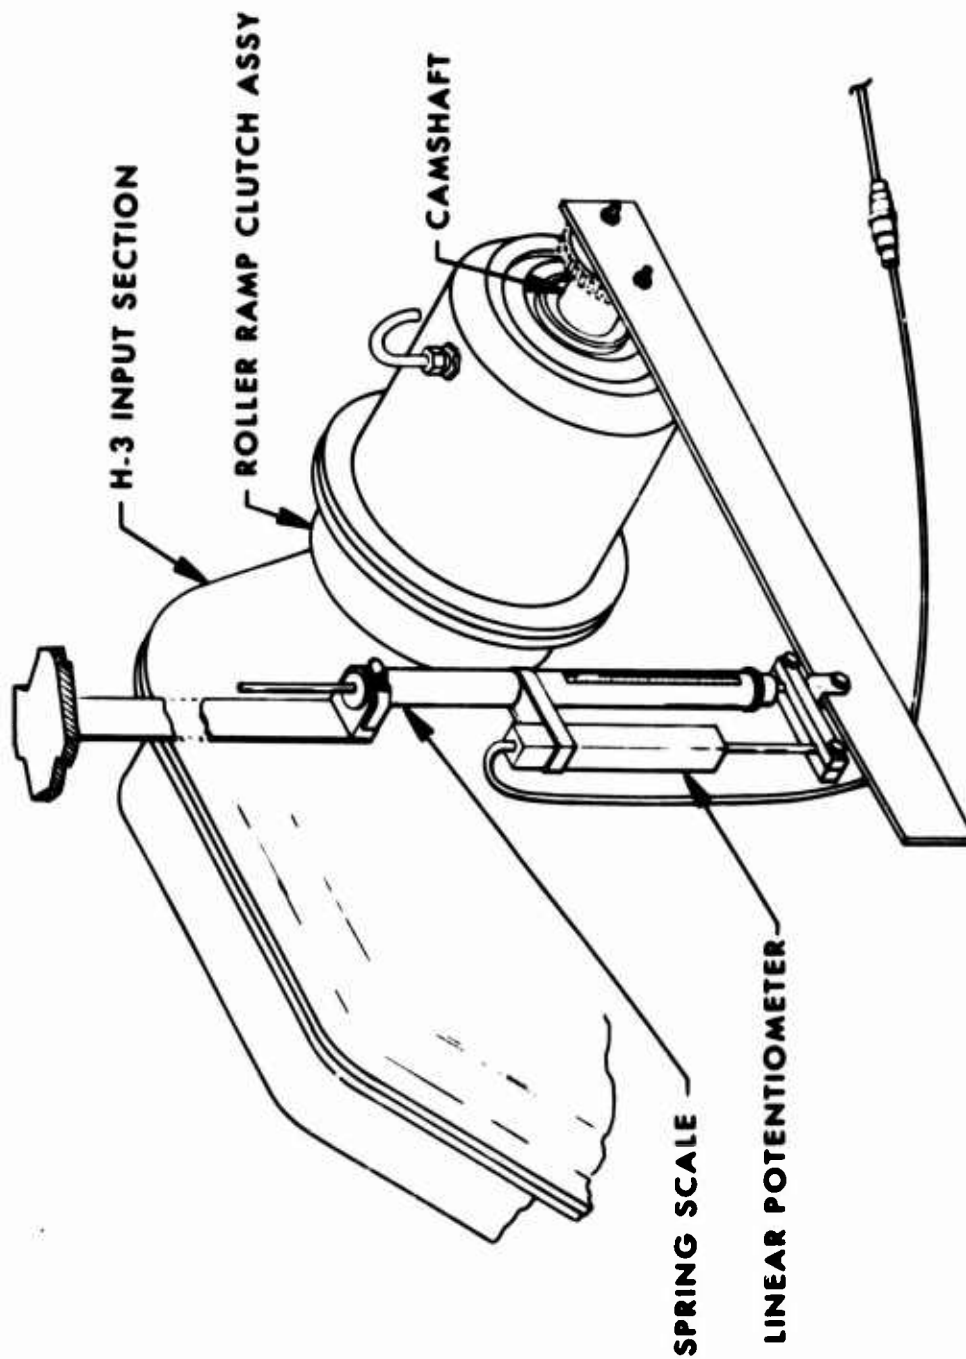
Figure 5. Full-Speed Overrunning Drag Torque Measurement.

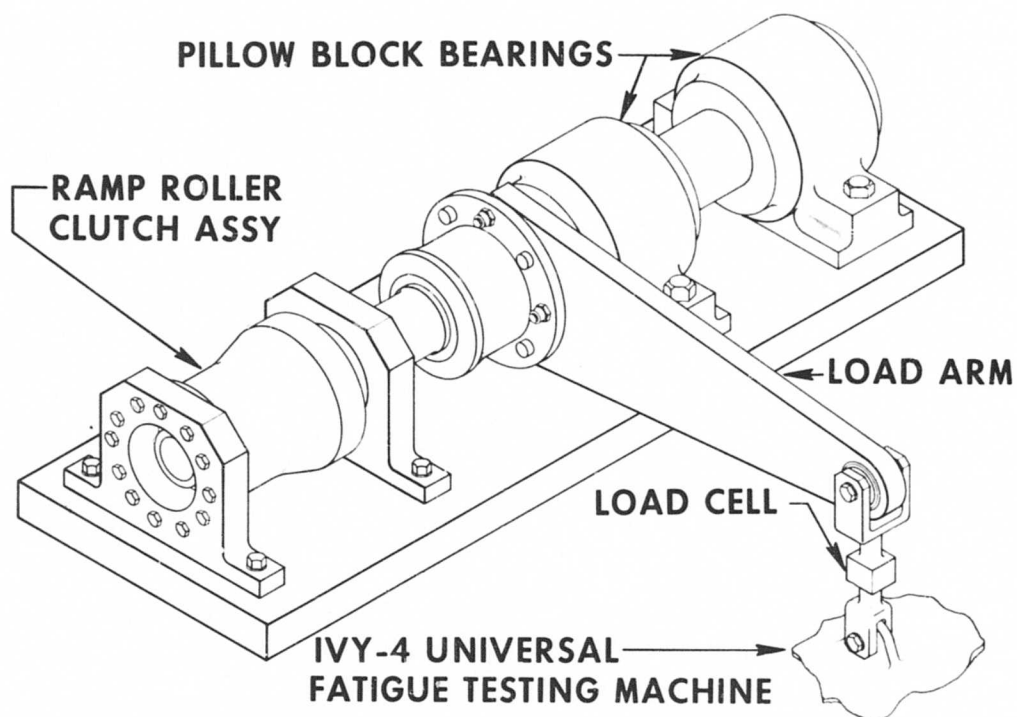
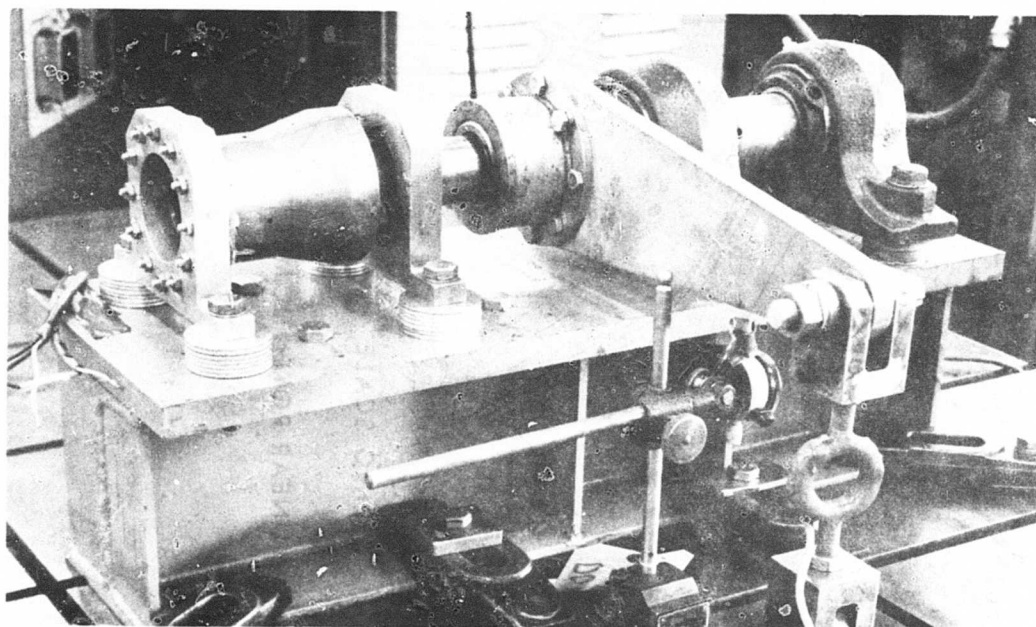
Figure 6. Schematic Arrangement, Static Test Facility.

The same clutch mounting fixture was installed on two different loading facilities to conduct the static cyclic and ultimate load tests. The clutch mounting fixture was installed on an IVY-4 Universal Fatigue Testing Machine during the static cyclic test and on a Static Universal Test Fixture with hydraulic cylinder during the overload test.

Cyclic torque of 7140 ± 900 inch-pounds is applied at 1800 cpm through a 12-inch torque arm mounted to the clutch camshaft. The clutch outer housing is bolted to a fixed support to react torque through the clutch. Load is continuously monitored by a calibrated load cell located between the torque arm

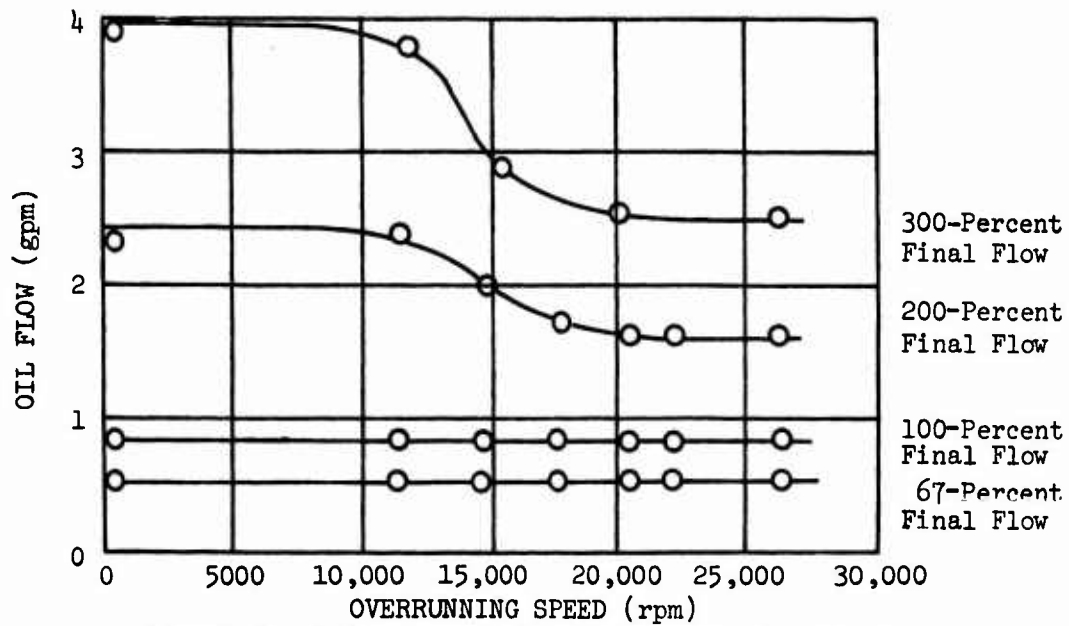
Figure 7. Influence of Housing Overrunning Speed on Pressurized Chamber Oil Flow.

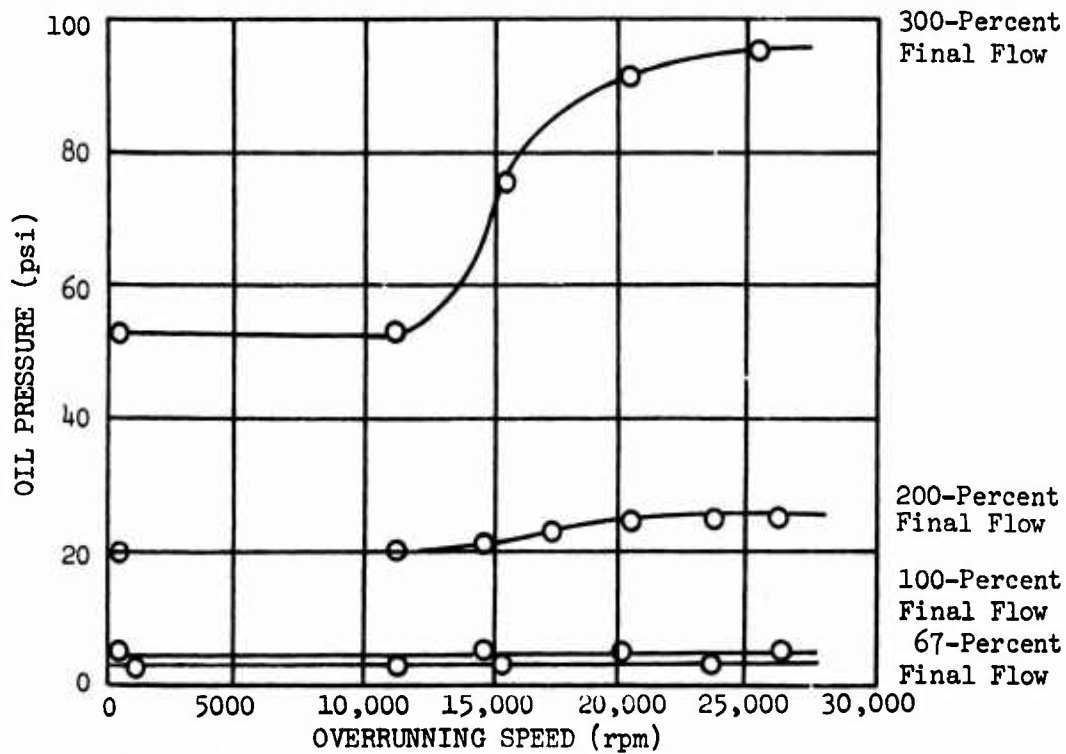
Figure 8. Influence of Housing Overrunning Speed on Clutch Inlet Oil Pressure.

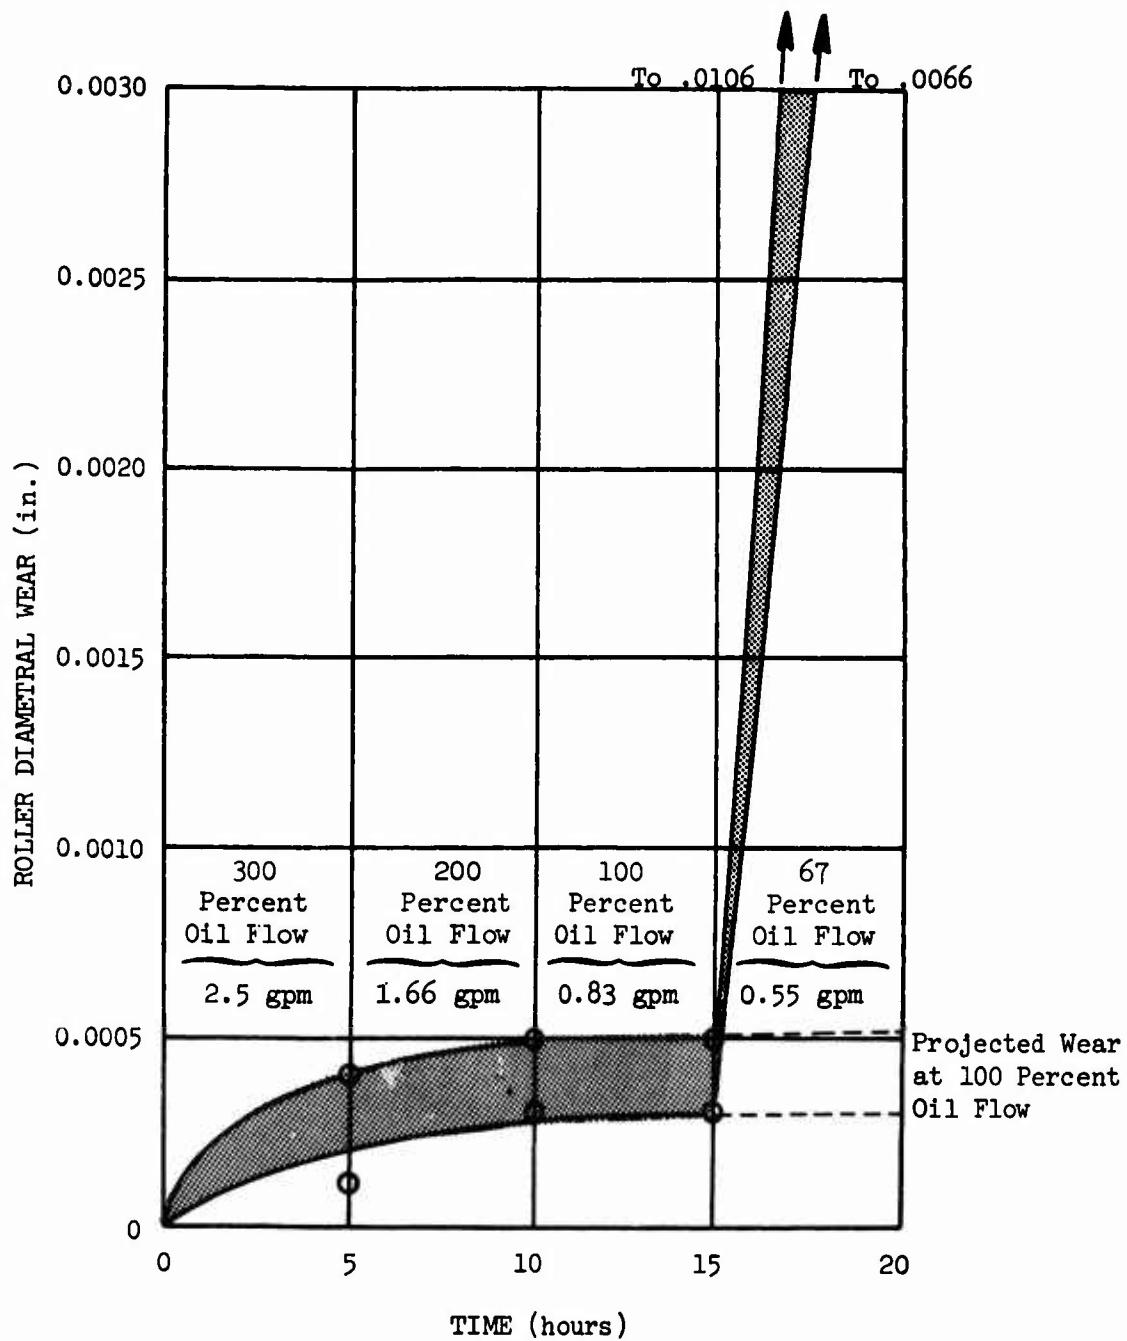
Figure 9. Full-Speed Overrunning Test Roller Wear.

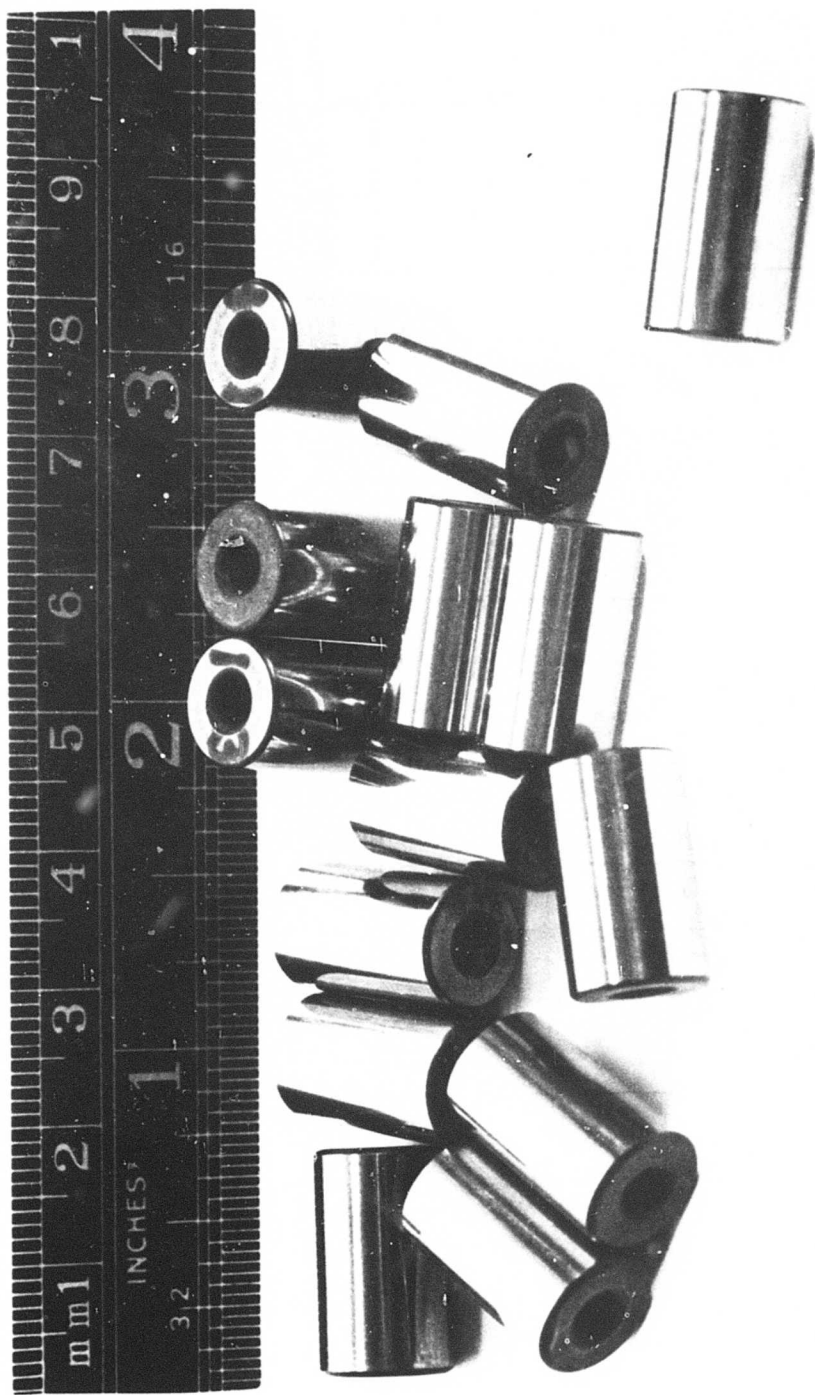
Figure 10. Condition of Rollers at Completion of Full-Speed Overrunning Tests.

The fourth test run of 5 hours duration was conducted at the 67-percent flow condition of 0.55 gpm. Post-test inspection results were markedly different from those of the previous tests. Total roller diametral wear from all previous tests ranged from 0.0003 to 0.0005 inch. During the 67-percent test, the roller diametral wear ranged from 0.0066 to 0.0103 inch. Roller wear data is shown in Figure 9 for all full-speed overrunning tests. Heavy sludge deposits were found in the oil-exchange-port area of the outer housing. Figure 10 shows the condition of the rollers after the 67-percent flow test. Although high wear was measured, as shown in Figure 9, the rollers were highly polished and perfectly round. The flame-plated outer housing, shown in Figure 11, showed wear for 360° and the full length of the roller

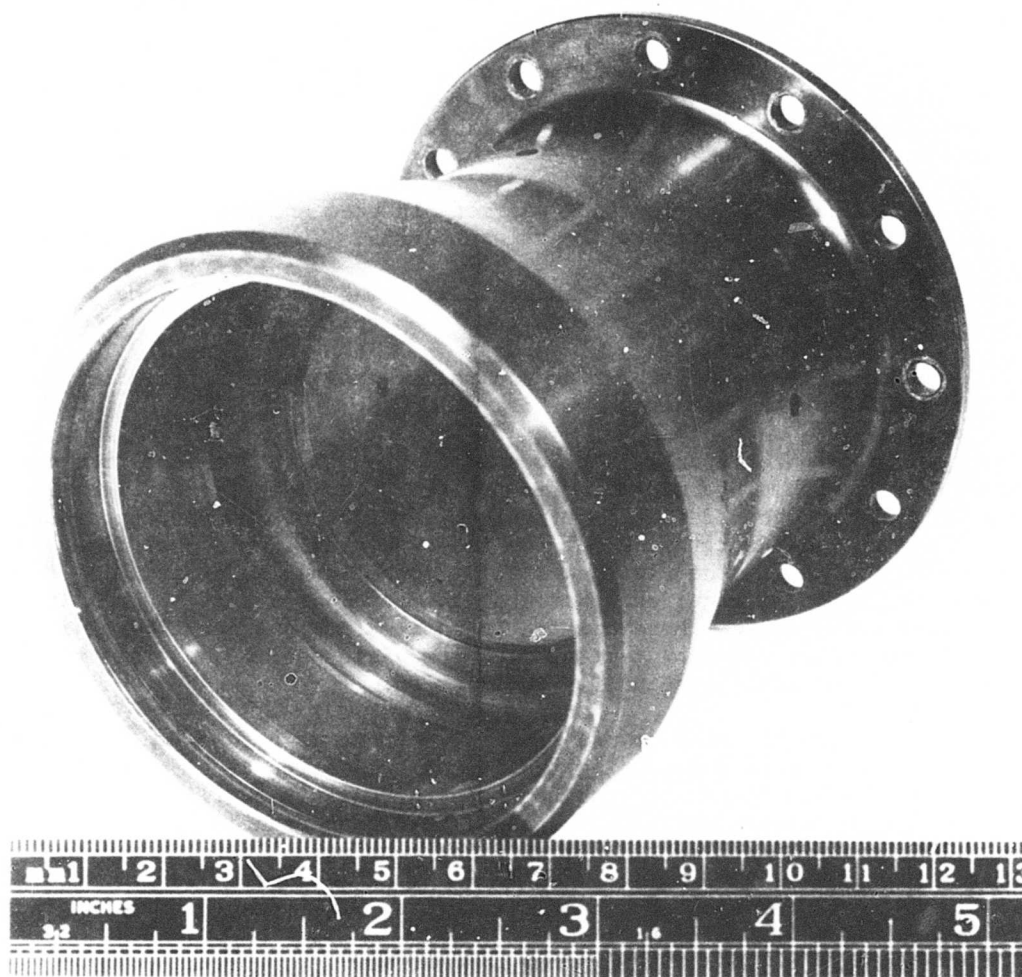
Figure 11. Condition of Outer Housing at Completion of Full-Speed Overrunning Tests.

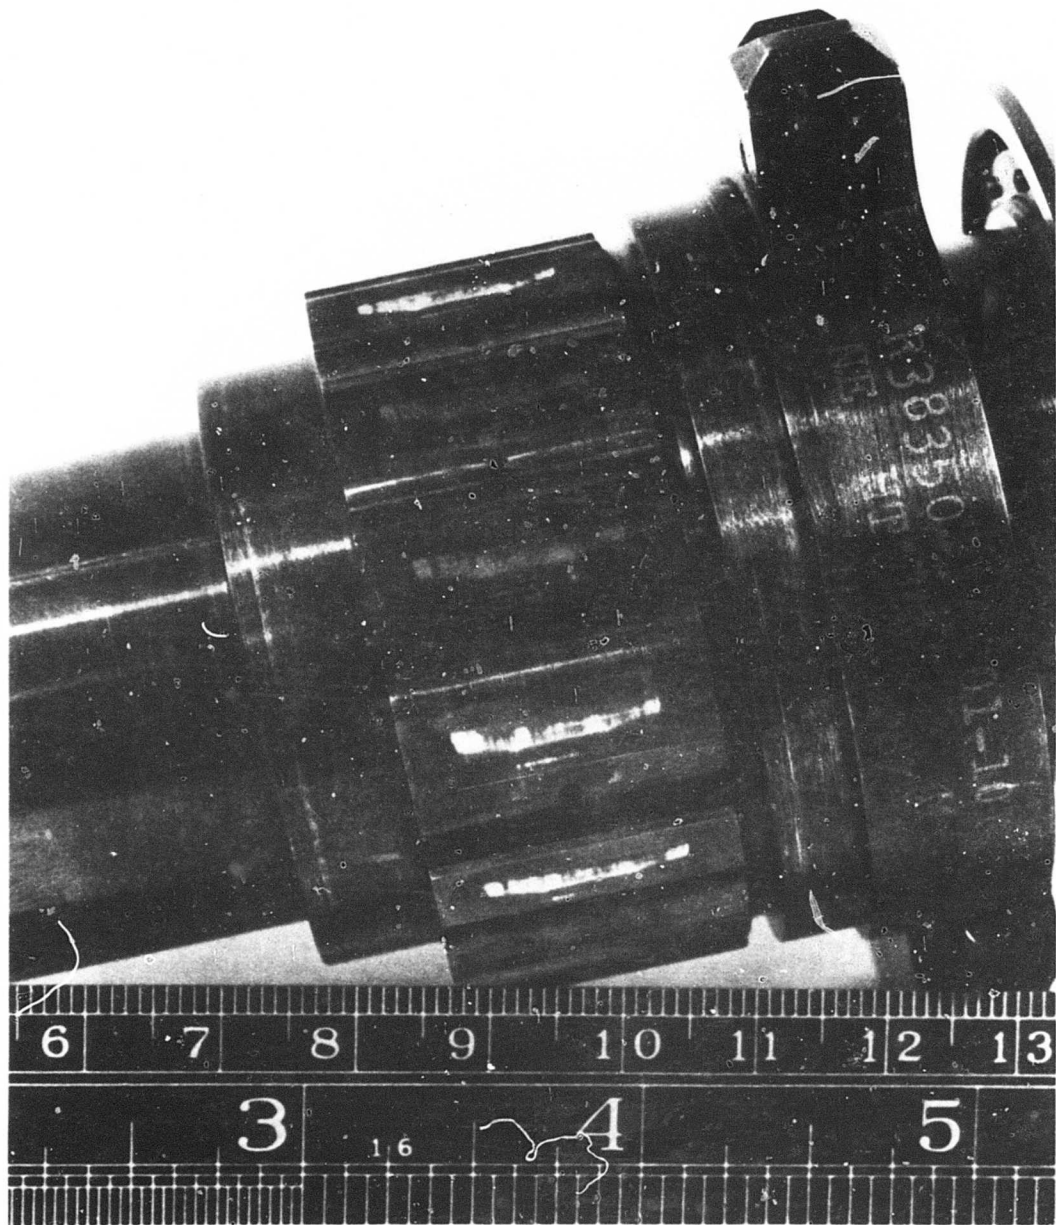
Figure 12. Condition of Cam Flats at Completion of Full-Speed Overrunning Tests.

contact area for a depth of 0.0002 inch. The cam flats exhibited a polished surface, as shown in Figure 12, but the depth of wear was less than 0.0001 inch. The outer housing support bearing nearest the clutch rollers had extensive heat and deformation damage as shown in Figure 13. Discoloration of the inner race showed a maximum temperature of 475° when matched to a standard temperature color comparator for 52100 bearing steel. Figure 14 shows all ramp roller clutch components after the 67-percent flow test of 0.55 gpm.

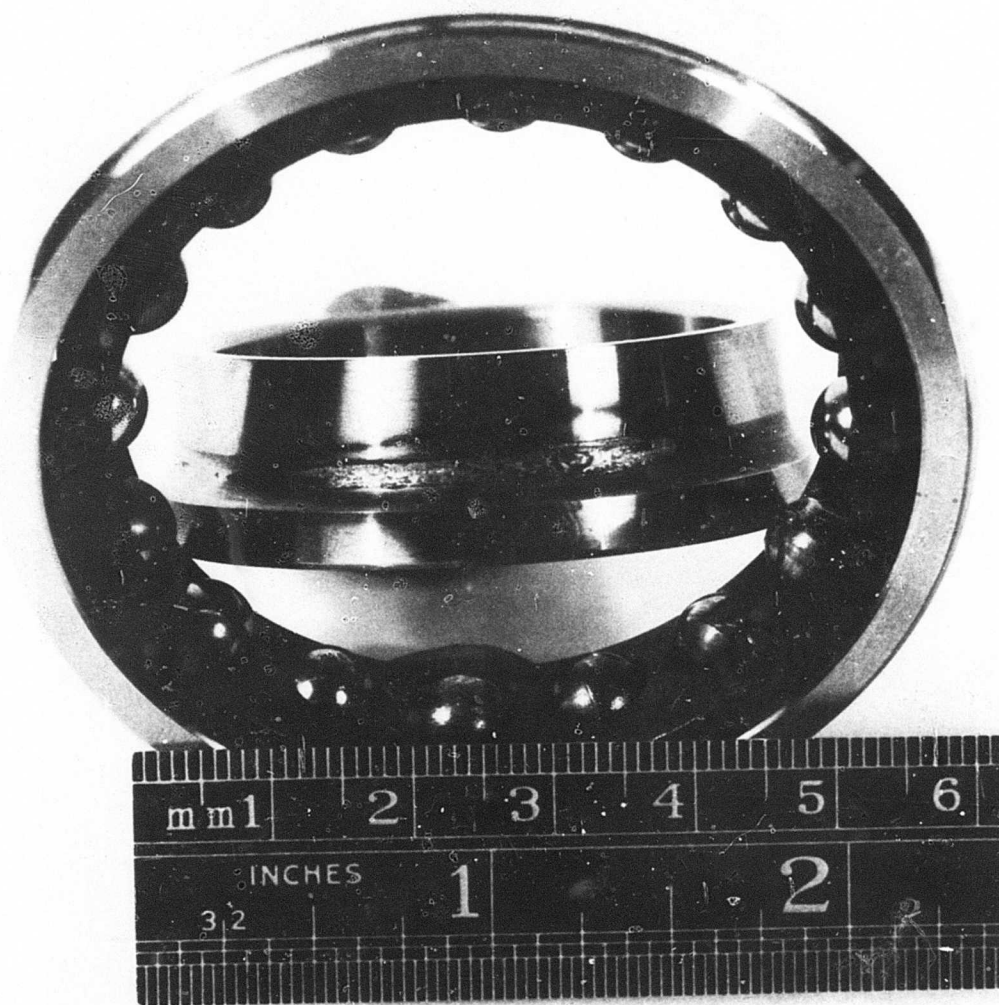
Figure 13. Forward Support Bearing Heat Damage,
67-Percent Oil Flow Overrunning Tests.

Examination of all clutch components showed that the high wear of rollers and overheating of the duplex bearing nearest the rollers were caused by insufficient quantity of lubrication. This conclusion is based on the following facts:

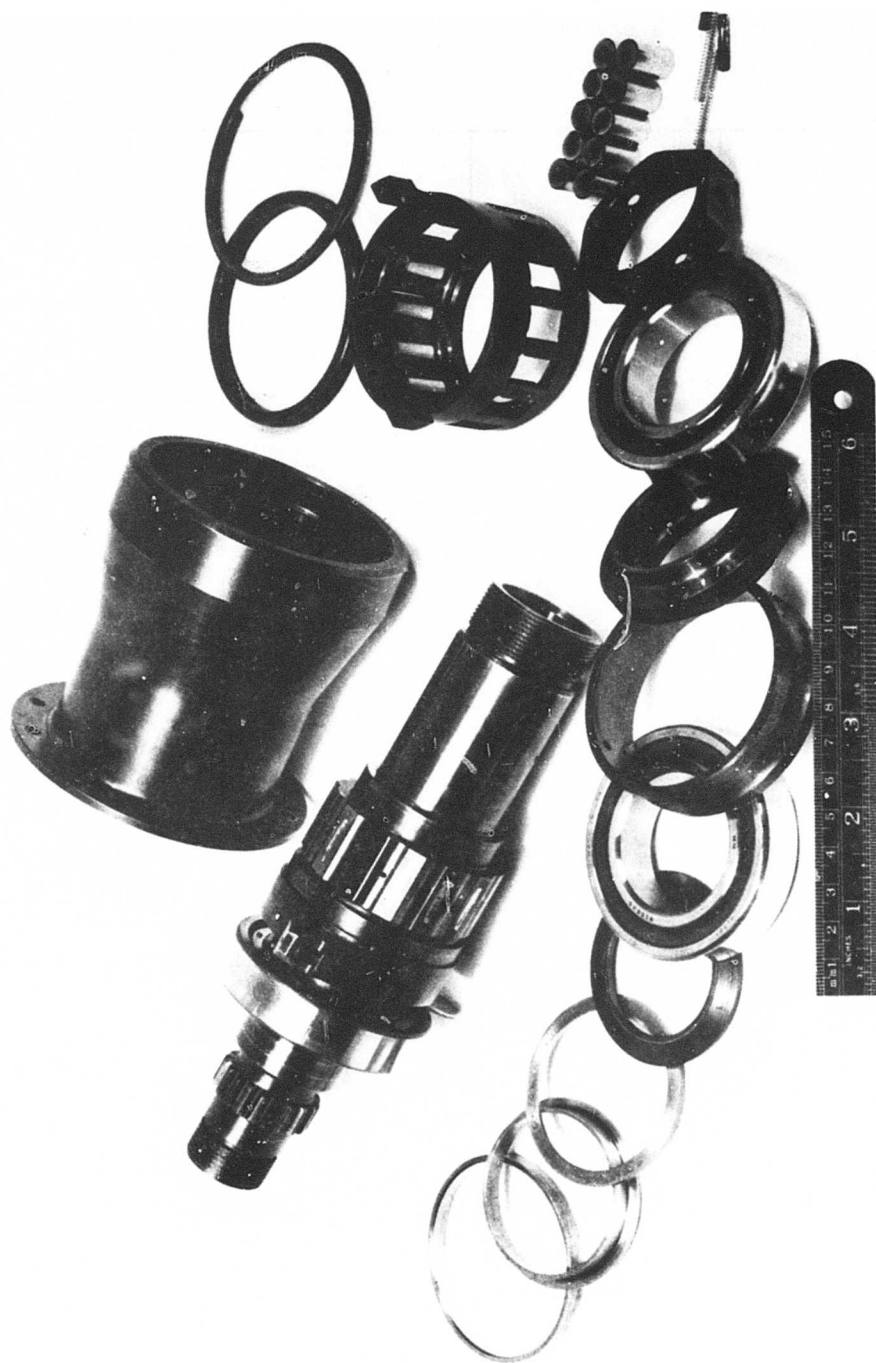
Figure 14. Clutch Components After Full-Speed Overrunning Tests.

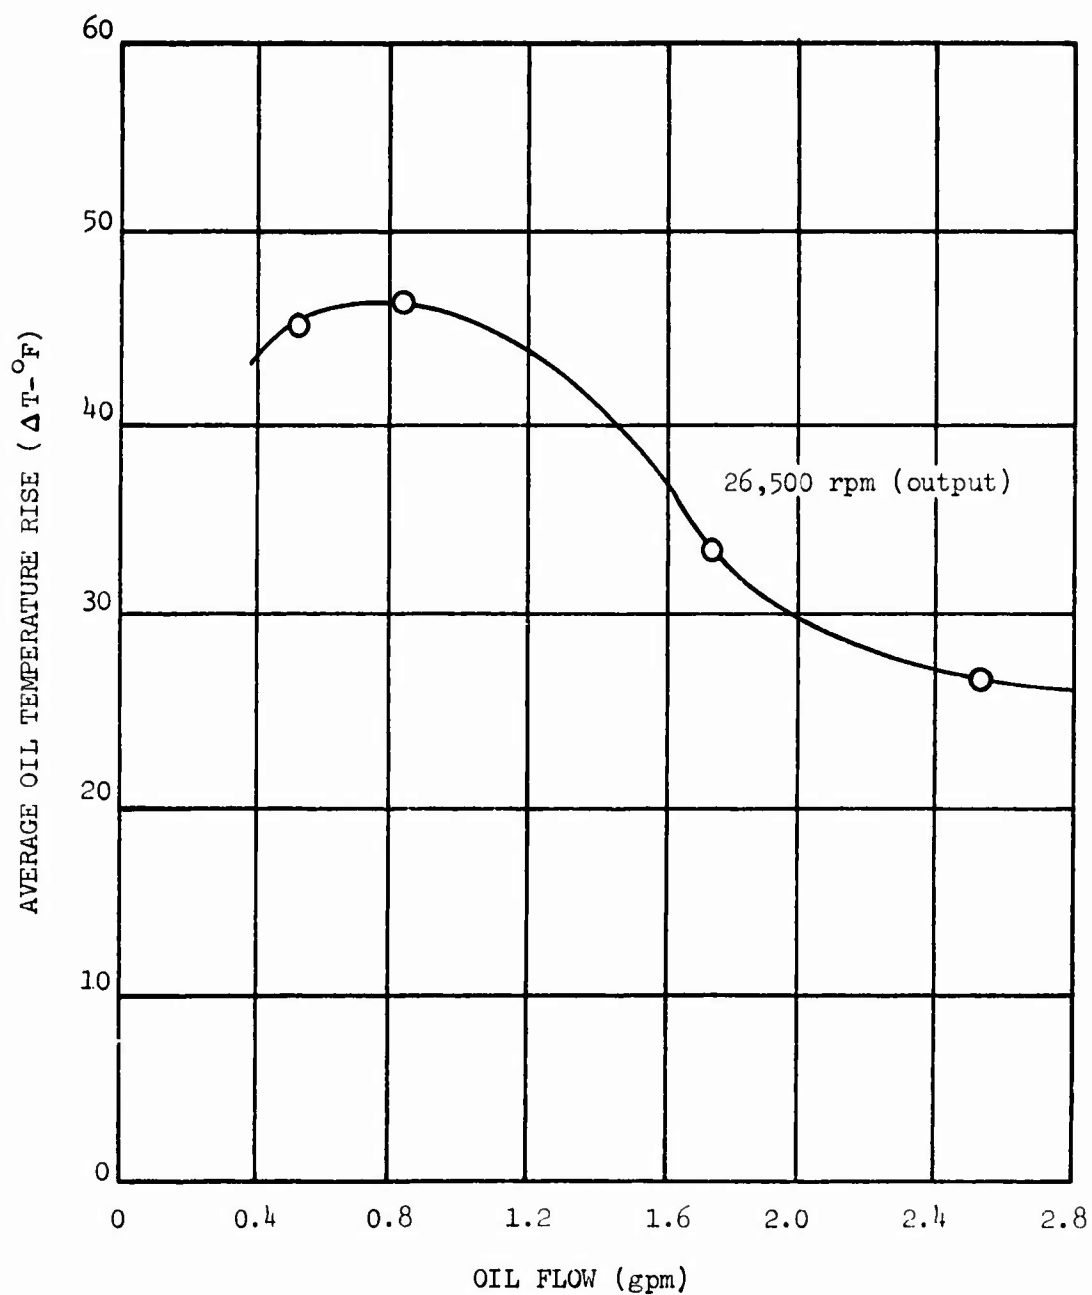
Figure 15. Variation of Oil Temperature Rise With Oil Flow at Full-Speed Overrunning. (Input Stationary)

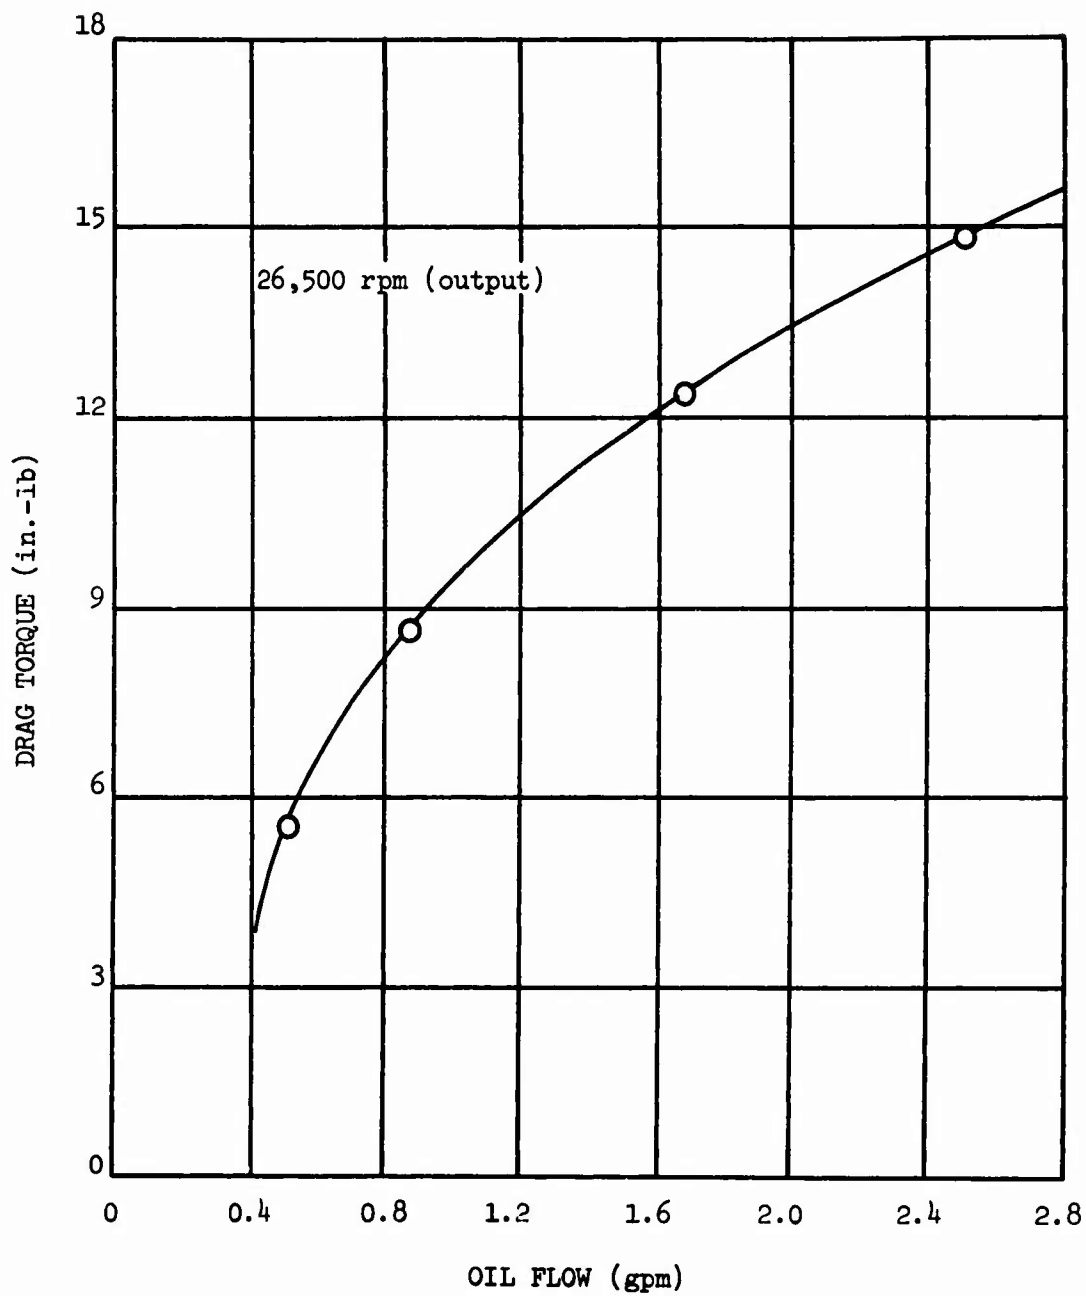
Figure 16. Effect of Oil Flow on Drag Torque, Full-Speed Overrunning. (Input Stationary)

Figure 16 is a graph of full-speed overrunning drag torque as a function of flow.

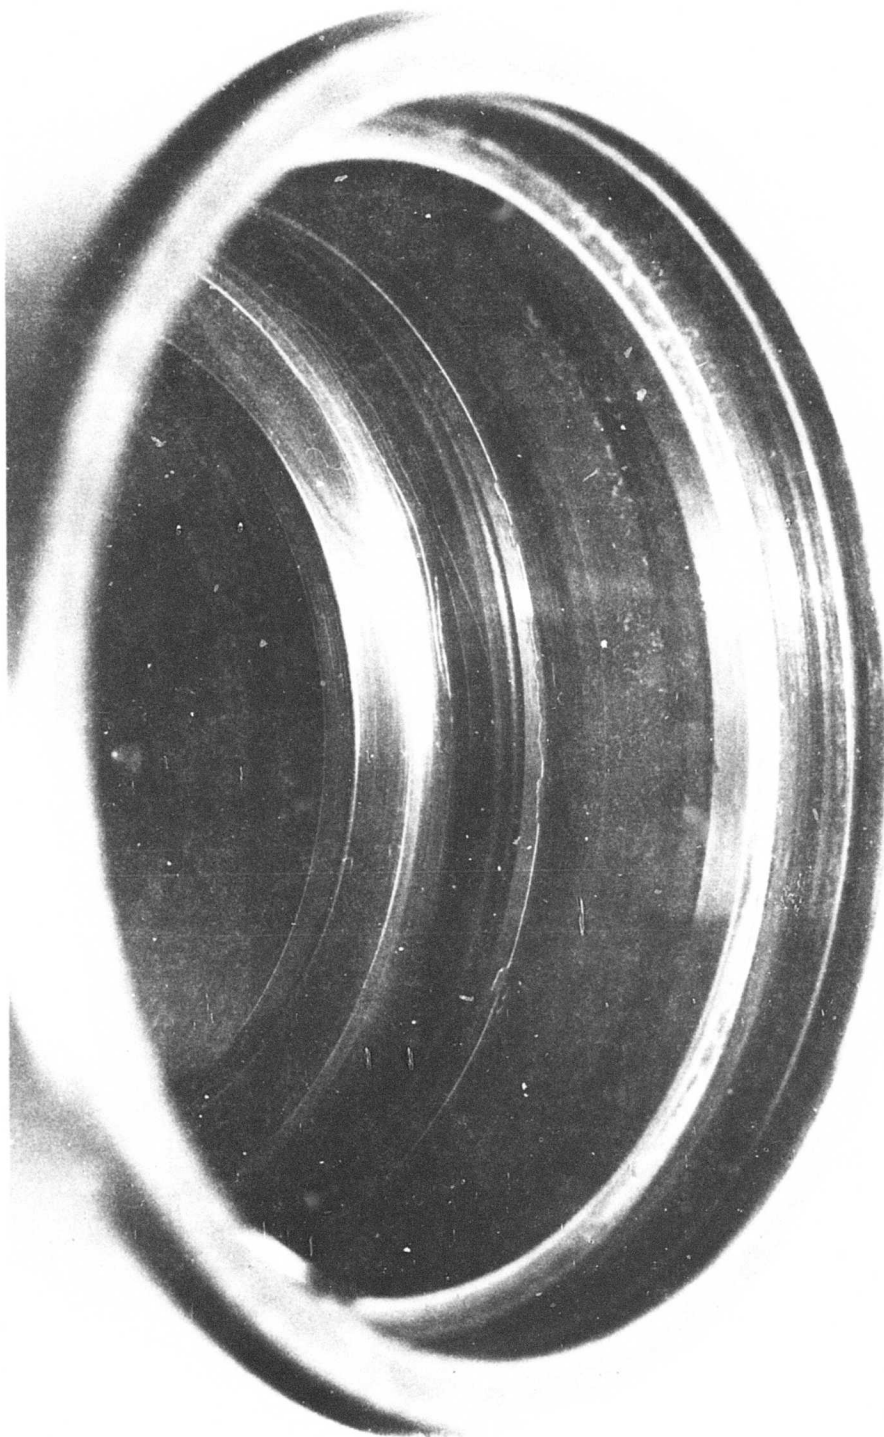
Figure 17. Wear of Tungsten-Carbide Flame Plating on Outer Housing After 50-Percent Differential-Speed Overrunning Test.

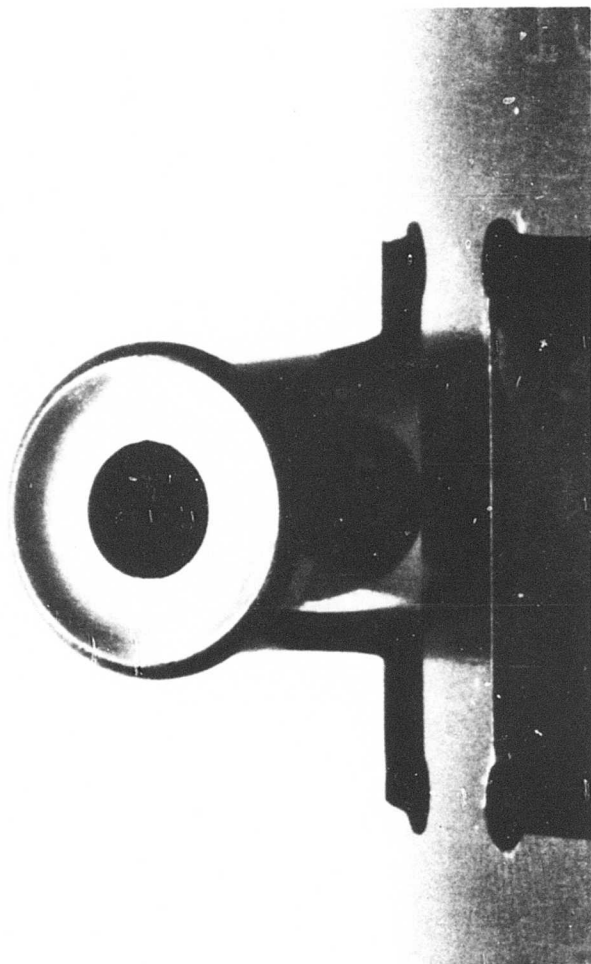
Figure 18. Roller End Wear, 50-Percent Differential-Speed Overrunning Test.

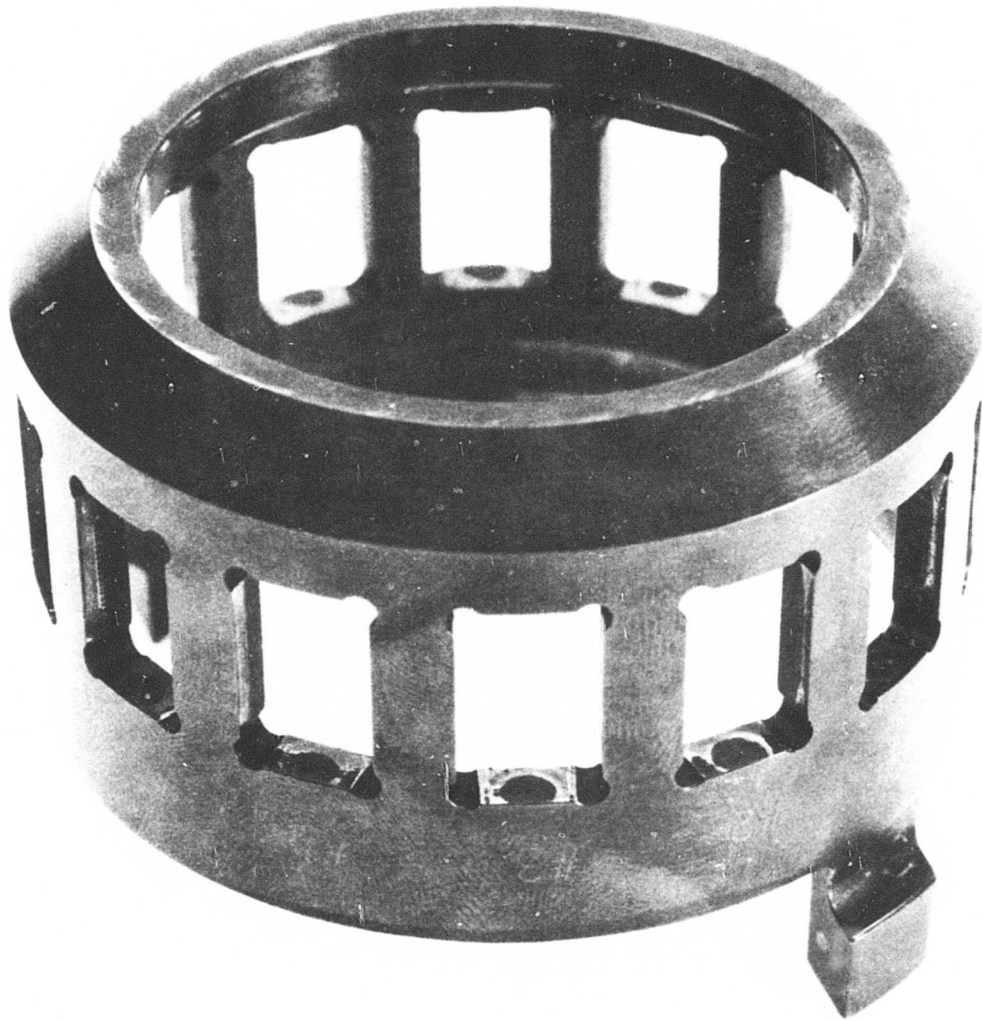
Figure 19. Roller Retention Cage Wear, 50-Percent Differential-Speed Overrunning Test.
